## Cortenstahl

### 1. Material description and grade

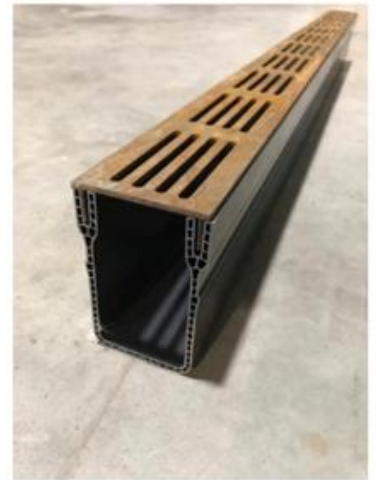
The particular advantage of this material lies in the formation of a so-called **protective patina** (rust layer), which develops when exposed to the elements and protects the underlying material from further corrosion.

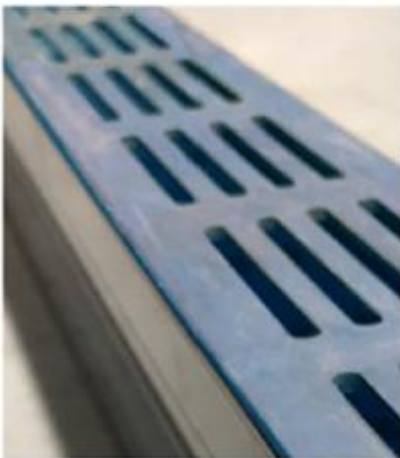
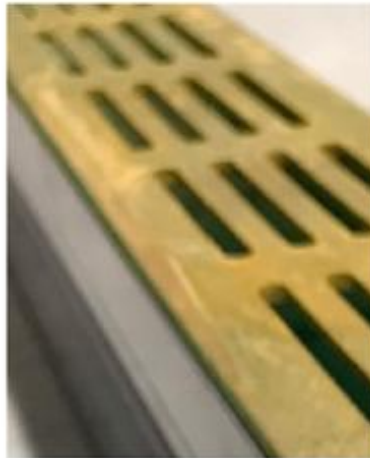
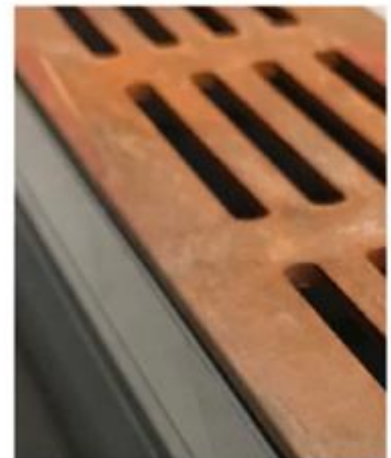
During the initial phase of weathering, **discolouration may occur due to rusty water**. Rust particles may become detached and transfer to adjacent materials.

- Patio slabs
- Natural stone or concrete surfaces
- Surfaces close to the façade
